DEPARTMENT OF HOUSING
COMMUNITY DEVELOPMENT BLOCK GRANT
DISASTER RECOVERY

153 TWIN BROOK ROAD
HAMDEN, CT

**PRE-REHABILITATION LEAD HAZARD RISK ASSESSMENT &
LEAD BASED PAINT PRE-RENOVATION XRF SCREENING
SITE 003 (BRAKEEM) – 153 TWIN BROOK ROAD, HAMDEN, CT
APPLICATION #2072, CS#183-76, 4/25/2014, 5/16/2014 AND 8/6/2014, Page 1 of 10**

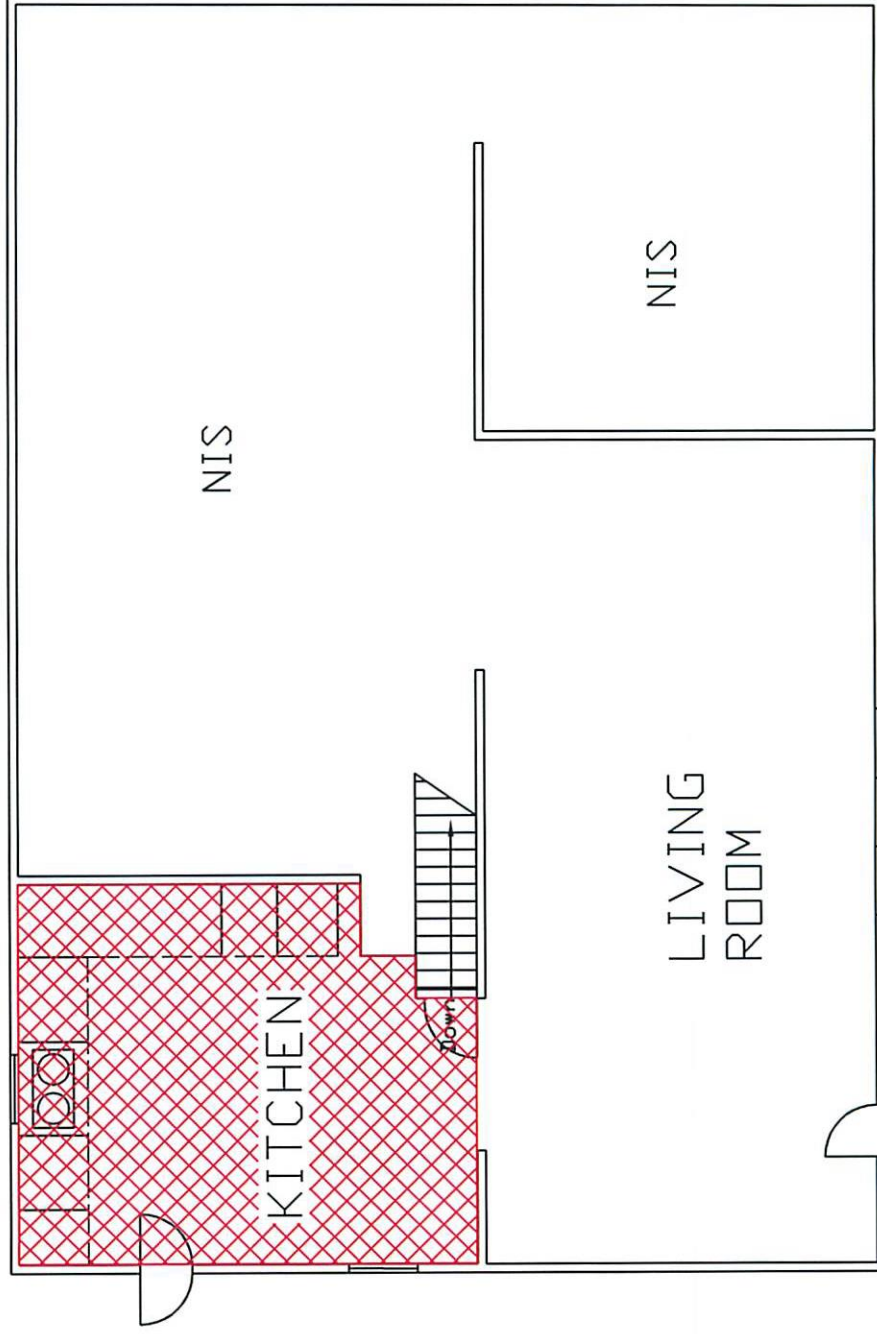
ACM LOCATION DRAWING

**>1% Asbestos was found in the combined results of the beige taping compound and the sheetrock layer; Consequently, the sheetrock and compound is OSHA and EPA-DPH regulated. With additional extensive sampling it may be possible to establish areas of non-asbestos taping compound, but additional sampling may also lead to more inconsistencies. See attached ACM location drawings for exact locations.

Asbestos removal is regulated by federal and state agencies. Abatement work must be done by a licensed asbestos abatement contractor using proper procedures and practices, including containment, decontamination facilities, negative air units and trained and CT DPH licensed workers. Final re-occupancy testing is also required, if the building is going to be reoccupied after the asbestos removal and strongly recommended even if the building is not going to be re-occupied such as in the case of building demolition, for removal of greater than three (3) sq. ft or linear ft of ACM. A CT DPH Licensed Project Monitor is always required for final visual inspections after asbestos removal.
